LA-UR-21-26974

Title: 2021 Hagan Container Surveillance Plan

2021 Hagan Container Surveillance Plan

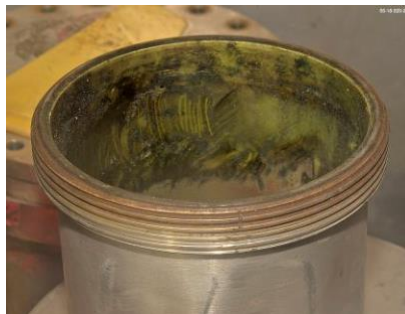
- Contamination detected on Outer Container (inner or outer surfaces)
- Corrosion outside of sealing surface (e.g. on Hagan threads, outside of filter, on TID wire, outside surfaces of lid or body)

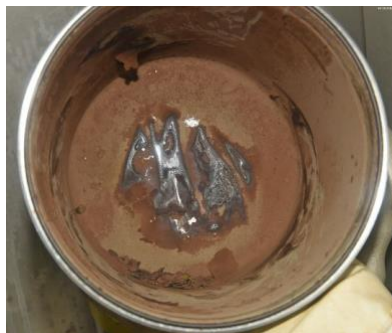
- Corrosion covering >95% of inside surface (little to no bare metal visible)

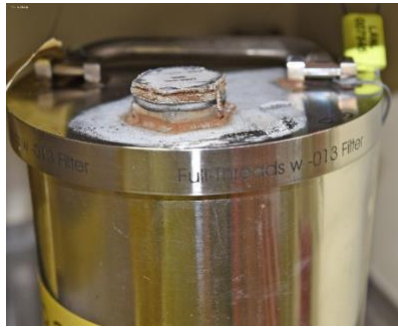
- White powder outside of sealing surface (e.g. near filter)

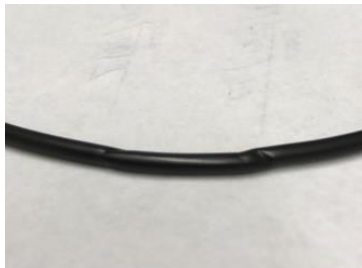
- O-ring missing
- O-ring crimped or damaged
